Installing PVC-Type Sidings in Cold Climates Beware of impermeable sidings without vented rainscreens

BY GEORGE TSONGAS

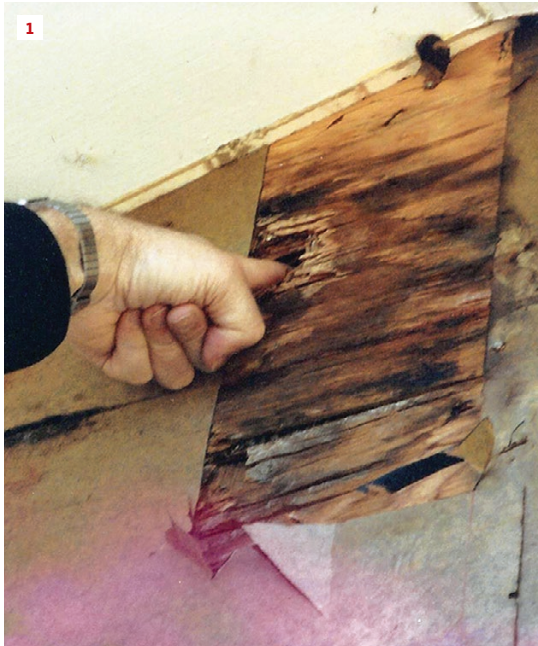
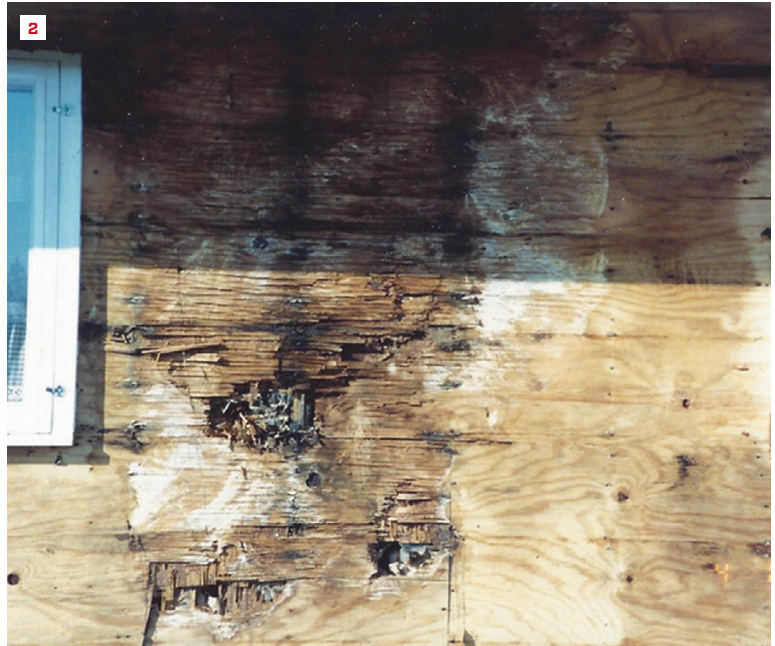
The effects of trapped water vapor. These walls (1, 2) on single-family homes in northern Wisconsin had been covered with a weather-resistant barrier (WRB) that acted as a vapor barrier. Moisture-laden indoor air migrated toward the outdoors by air leakage and vapor drive and condensed on the back of the sheathing, leading to extensive rot.

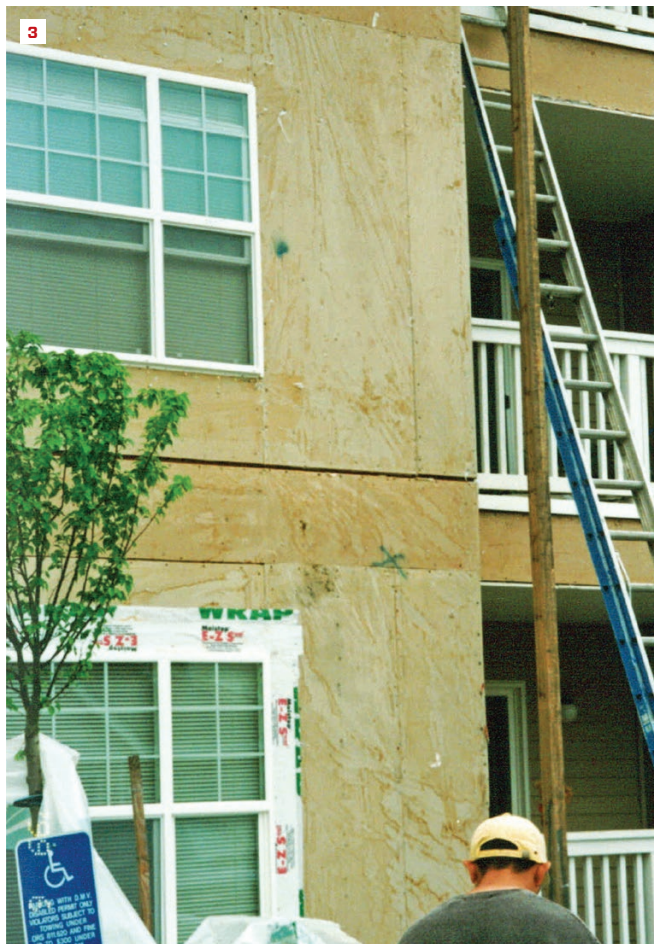
Increased moisture loads. Inspections of multifamily housing in Oregon revealed water staining on gypsum sheathing beneath contact-applied vinyl siding (3), and serious decay and mold damage on the OSB sheathing beneath the gypsum (4). With fewer walls facing the exterior in multifamily units, moisture loads driven by air leakage through those walls tend to be higher than in single-family homes, where an equivalent moisture load may be driven through walls on all sides.

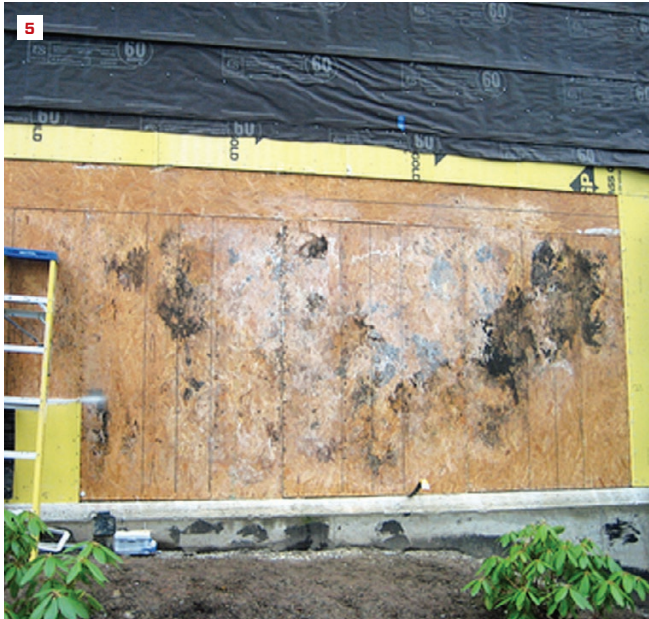
On a multifamily housing complex in Washington state, removal of contact-applied vinyl siding, paper, and gypsum sheathing revealed moldy, decayed OSB (5). The damage was worse on the inside face of the OSB. On a different housing complex in Oregon (6), moisture driven from the interior caused sporadic deterioration of the WRB and decay of OSB sheathing.

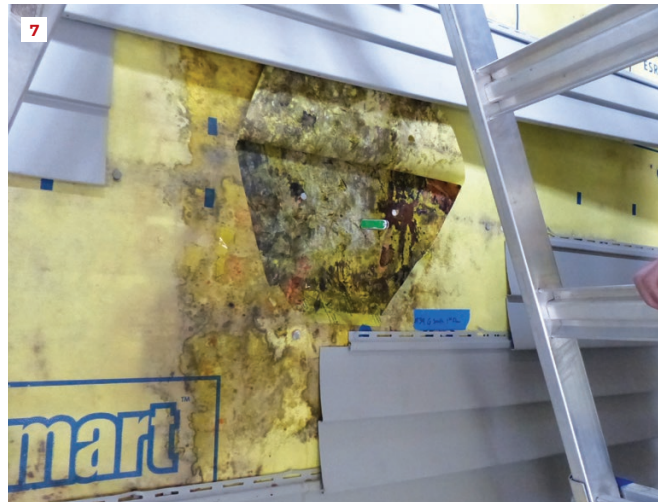
On the walls of the same Oregon housing complex shown on the facing page, deterioration of the OSB and WRB occurred sporadically, but the worst damage correlated with bedrooms with high indoor air dew-point temperatures. Note the green pen knife, which easily penetrated the OSB (7). A similar condition was found in a wall beneath vertical board-and-batten-style vinyl siding (8).
