## Building America Efficient Solutions for Existing Homes

# Case Study: Deep Energy Retrofit in the Pacific Northwest

Portland, Oregon

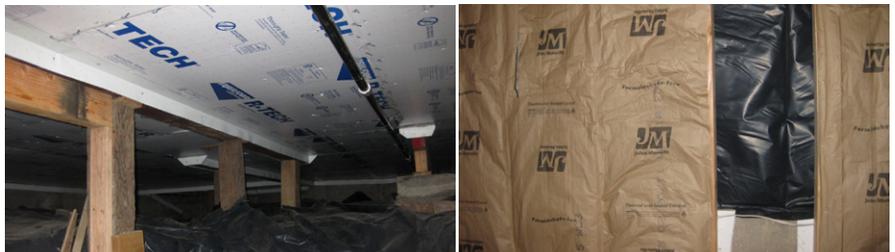
(left) In the crawlspace, R-30 fiberglass batts were installed between the 2x10 floor joists. The joists were then covered with 1 inch of expanded polystyrene (EPS) rigid foam board that was taped at the seams to provide a continuous air barrier and flashed at the edges to protect against rodents. The crawlspace floor was covered with a 6-mil visquene vapor barrier.

(right) On the lower 4 ft of the concrete basement walls 1" EPS was installed. Then a new 2-ft-high concrete stem wall was added in front of the rigid foam to support the aging existing foundation wall. The upper portion of the wall was covered with a plastic vapor barrier and framed with 2x4 studs; R-15 faced fiberglass batts were installed between the studs. Taped and mudded sheetrock provided a fire barrier, air barrier, and finished look to the basement wall assembly.

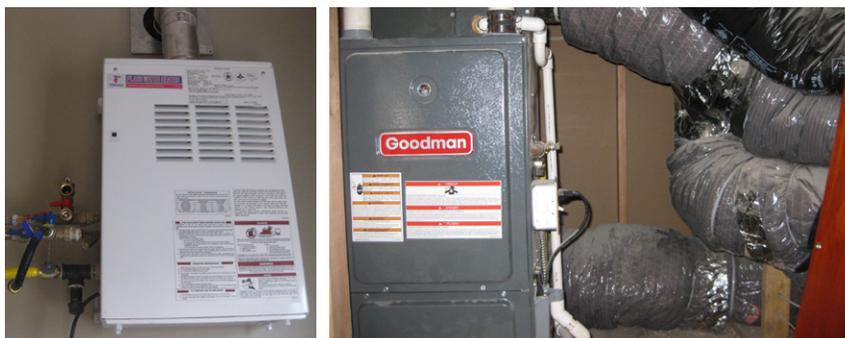
New high-efficiency heating and cooling equipment, water heater, and appliances lower energy consumption and improve indoor air quality.

(left) A 0.85 EF tankless hot water heater eliminates standby energy consumption.

(right) The 95% AFUE, sealed-combustion gas furnace and well-insulated and sealed ducts, are located in an insulated but air and vapor permeable side attic.
