COMPREHENSIVE ENERGY RETROFIT

Case Study: Consortium for Advanced Residential Buildings (CARB) – Washington, D.C.

145-year-old row house in Washington, D.C.’s Capitol Hill neighborhood

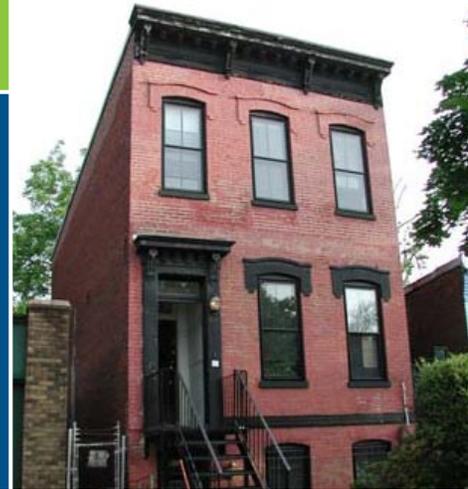
The whole-building approach was followed in retrofitting this 145-year-old house in Washington, D.C.’s Capitol Hill district.

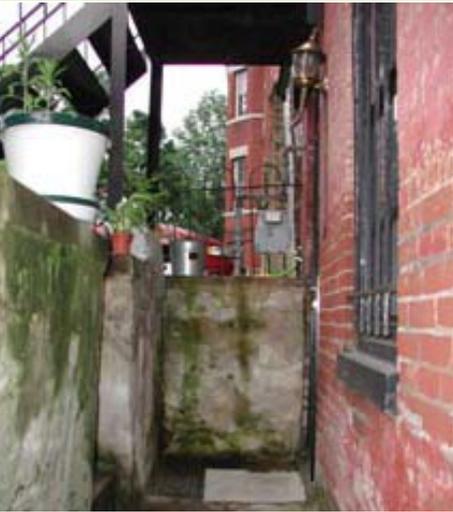
Rainwater collecting next to a home's foundation can impact the structural integrity of the home.

To mitigate moisture problems at this home, CARB suggested cleaning out drains, sloping soil away from the home where possible to direct water away from the foundation, and installing an under-deck drainage system to divert rainwater away from the house.

During the CARB visit, the team determined the structural integrity of the building to be sound. However, the site had drainage problems because the drains installed in the pavement had filled with sediment over the years, resulting in moisture problems around the foundation. Also, improper flashing of the two back decks caused water penetration into the house. As part of Building America's whole-building approach, it is essential to address moisture problems on the exterior of the house to help prevent interior moisture problems.

To solve the moisture problems, CARB recommended cleaning out the drains, sloping soil away from the house to direct water flow away from the foundation, properly flashing the decks, and installing an underdeck drainage system to divert rainwater away from the house.

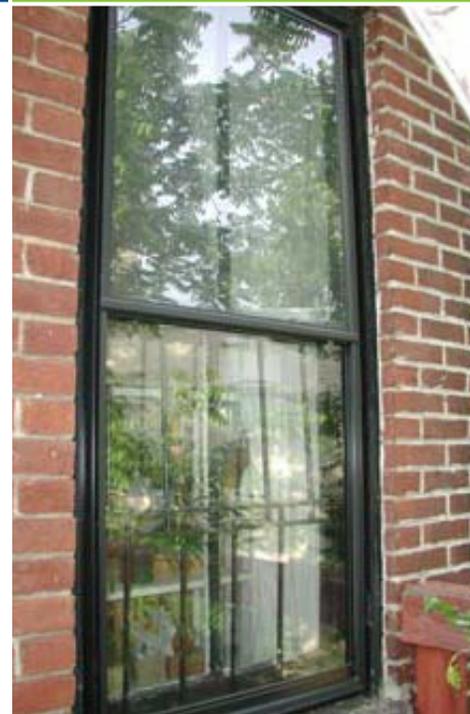
This single-pane aluminum-framed window was replaced with a soft-coat, low-emissivity wood-framed window (U-0.39, SHGC 0.46). Wood frames are required on windows visible from the street in the historic district.

The single-pane windows leaked and were deteriorating. CARB suggested replacing these with soft-coat, low-emissivity double-pane windows. Wood-framed windows (U-0.39, SHGC 0.46) were used in the home's front to meet historic compliance and vinyl-framed windows (U-0.36, SHGC 0.45) were used in the back.

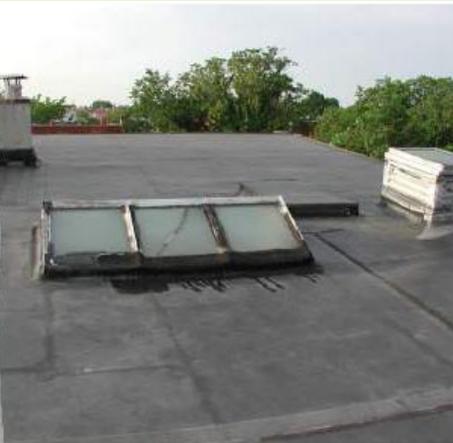
The pre-rehab roof leaked at its connection with the skylight.

The roof had been leaking for a year and needed to be replaced. CARB recommended stripping the roof down to the roof decking, repairing the roof decking as needed, and installing a thermoplastic polyolefin (TPO) single-ply roofing membrane on top of 5-inch polyisocyanurate rigid foam insulation (R-30).
